# Quantifying the Water Quality Benefits of a Restored Tidal Stream Using Intensive Nitrate and Flow Monitoring

J. Randall Etheridge, François Birgand, and Michael R. Burchell II

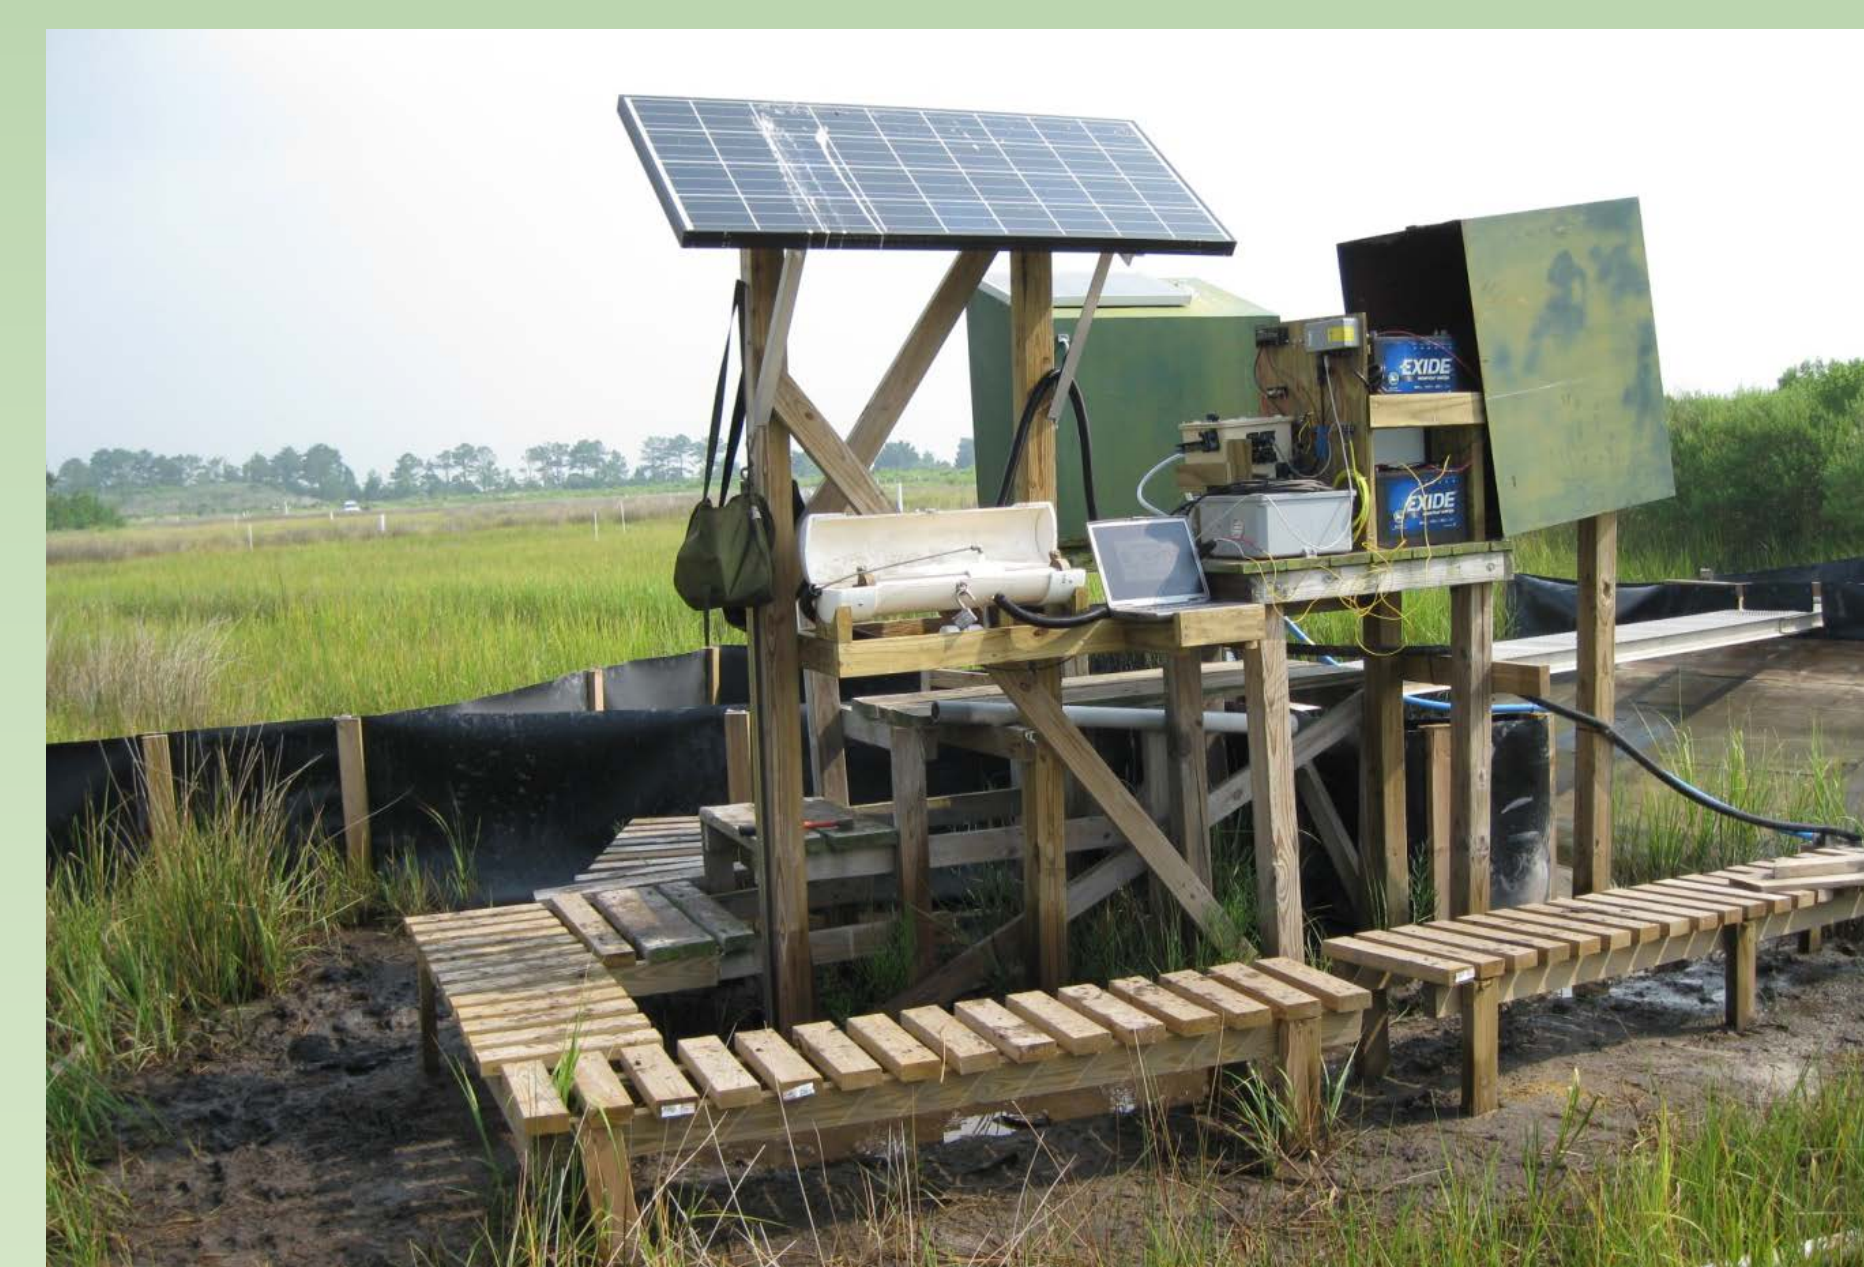
Figure 7. The downstream monitoring station in July 2011 after the spectrophotometer was removed from the stream.

- Solution: Remove probe from the stream and pump water to the probe (Figure 7)
- Pumping system sequence:
  - Pump water from the stream to the spectrophotometer
  - Take measurement
  - Drain stream water and purge the system
  - Rinse the measurement windows with pressurized tap water
- Result: Fouling greatly reduced
