# **Impacts of on-site sewage disposal systems on Jupiter Creek, an urbanized tidal creek in Southeast Florida, USA**

Brian Lapointe, Marie Tarnowski\* and  
Steve Krupa

# Jupiter River Estates

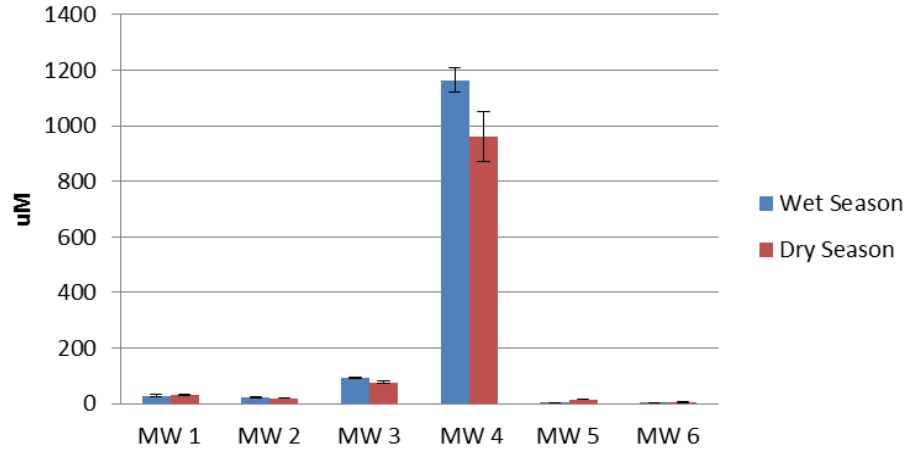
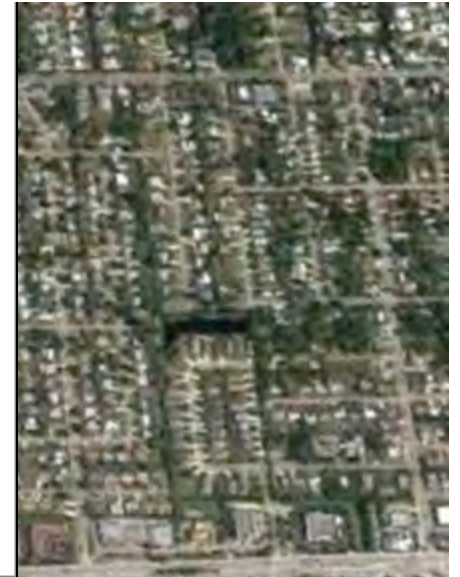
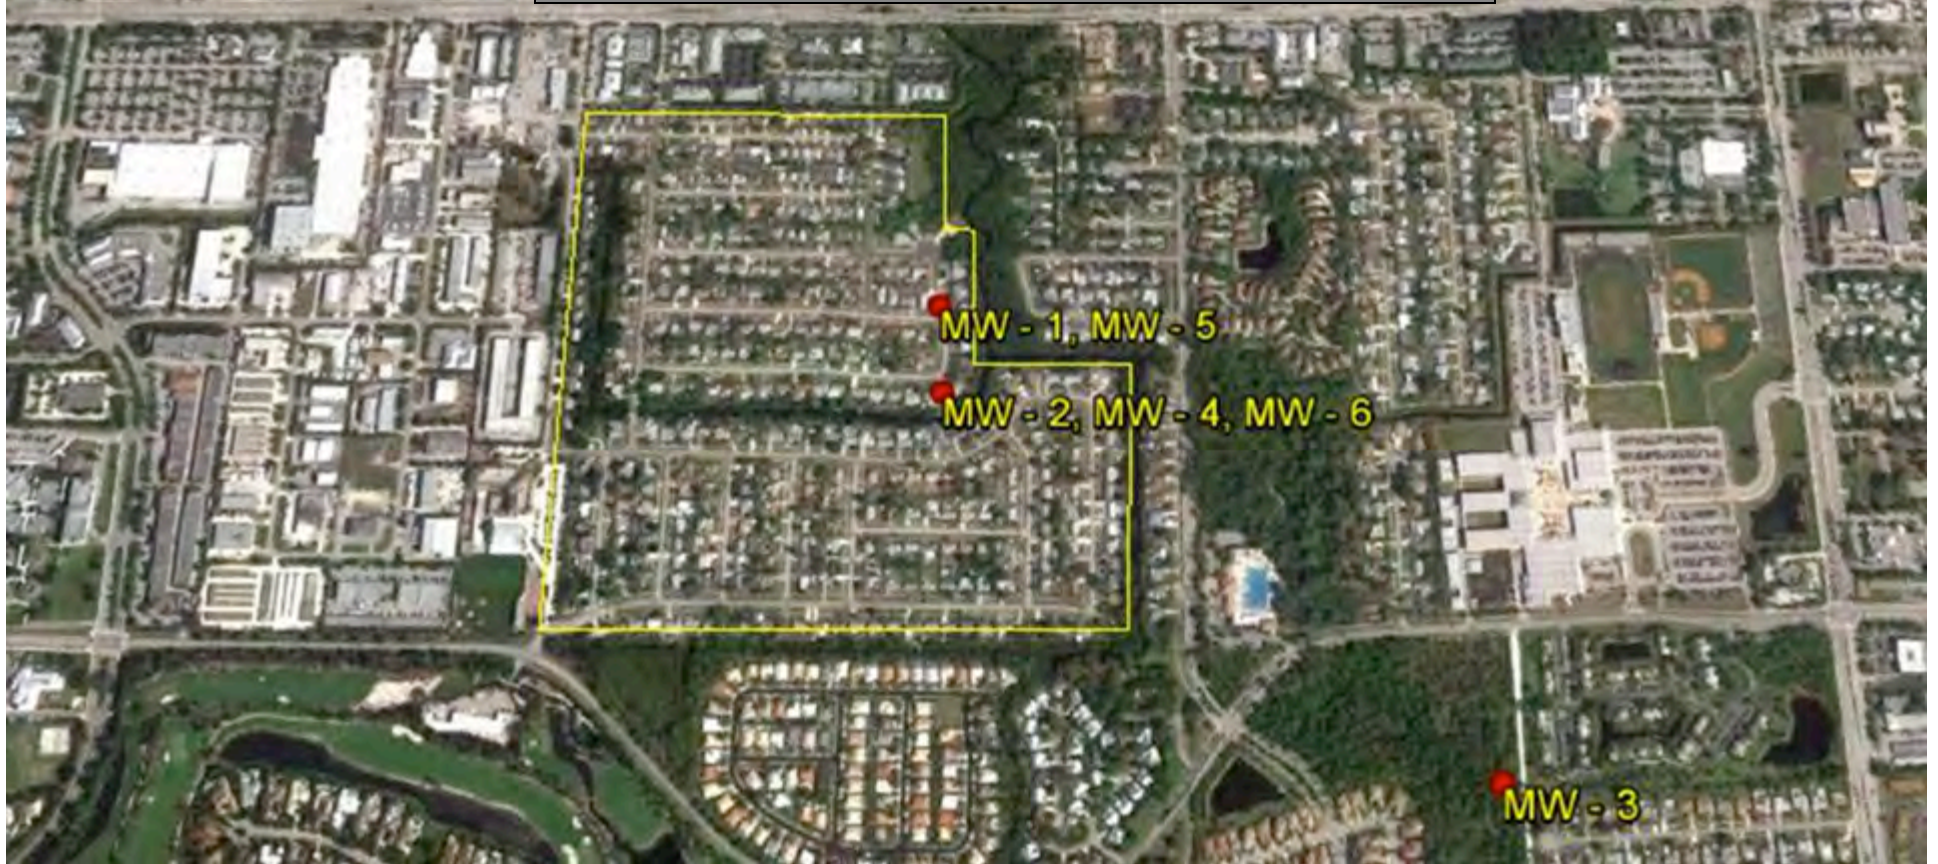
Monitor Well Ammonium ( $\mu\text{M}$ ) Levels:  
Wet vs Dry Season

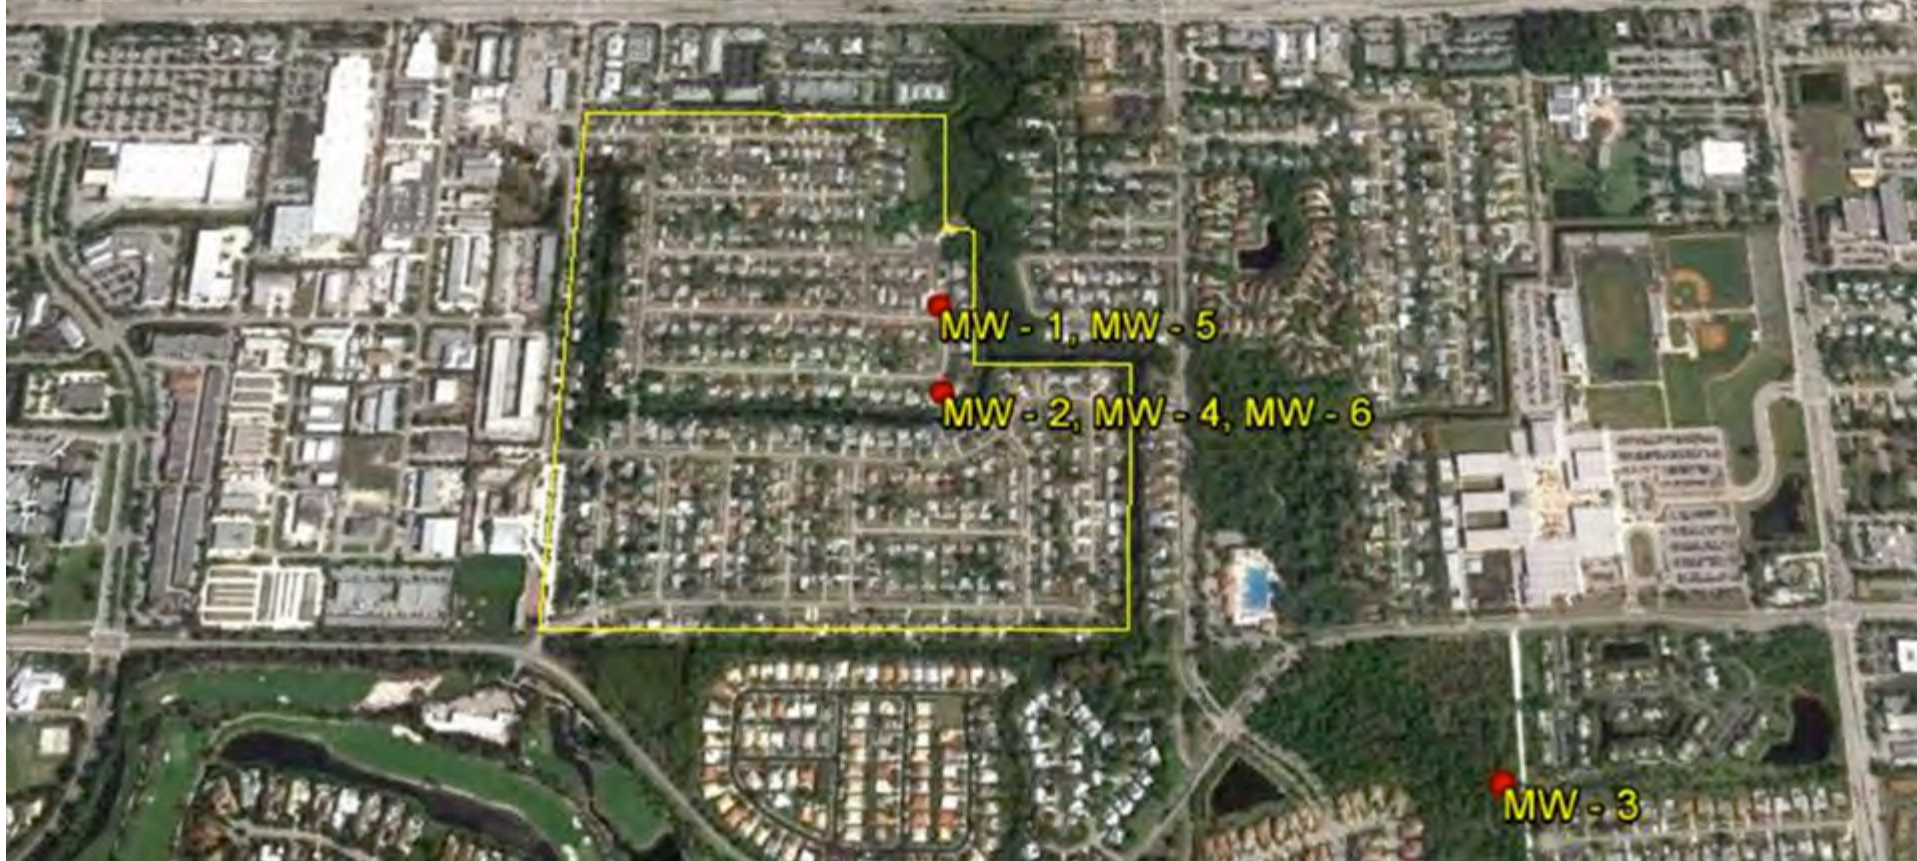
Monitor Wells 1-4 Nitrate/Nitrite (uM) Levels:  
Wet vs. Dry Season

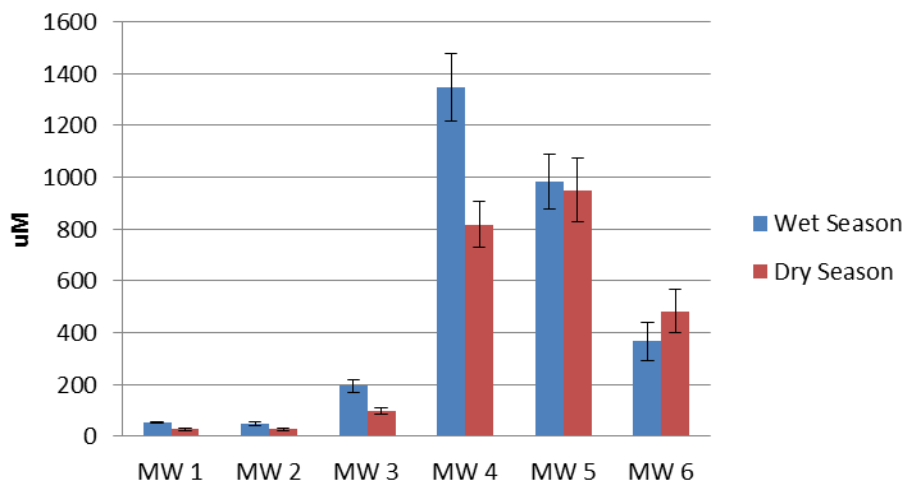
Monitor Wells Total N (uM) Levels: Wet vs. Dry Season

MW - 1, MW - 5

MW - 2, MW - 4, MW - 6

MW - 3

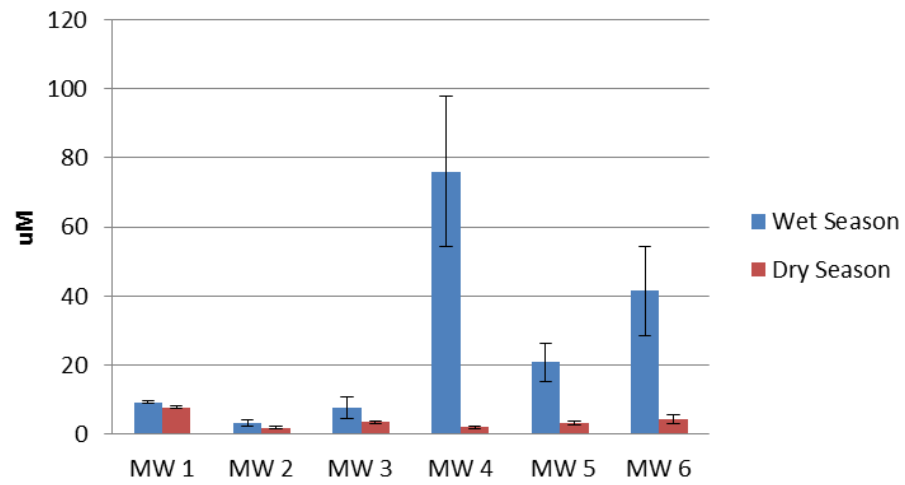
Monitor Well Total P ( $\mu\text{M}$ ) Levels: Wet vs. Dry Season

MW - 1, MW - 5

MW - 2, MW - 4, MW - 6

MW - 3

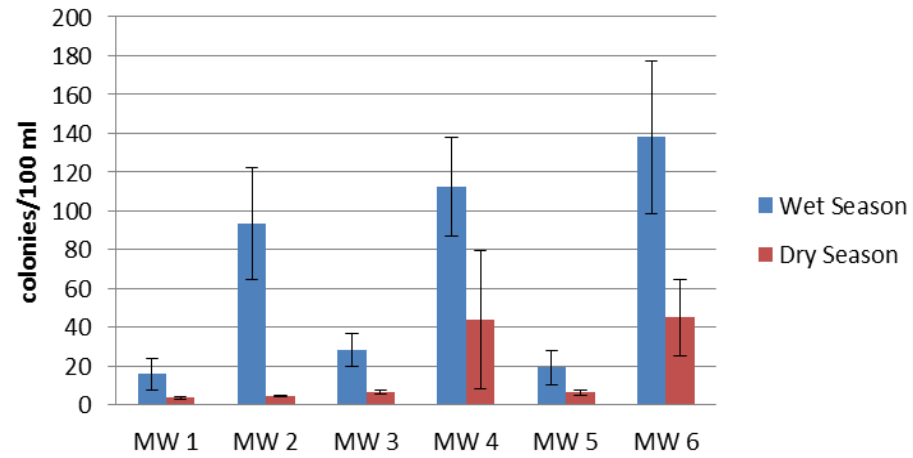
Monitor Wells Fecal Coliform (colonies/100 ml) Levels:  
Wet vs. Dry Season

MW - 1, MW - 5

MW - 2, MW - 4, MW - 6

MW - 3

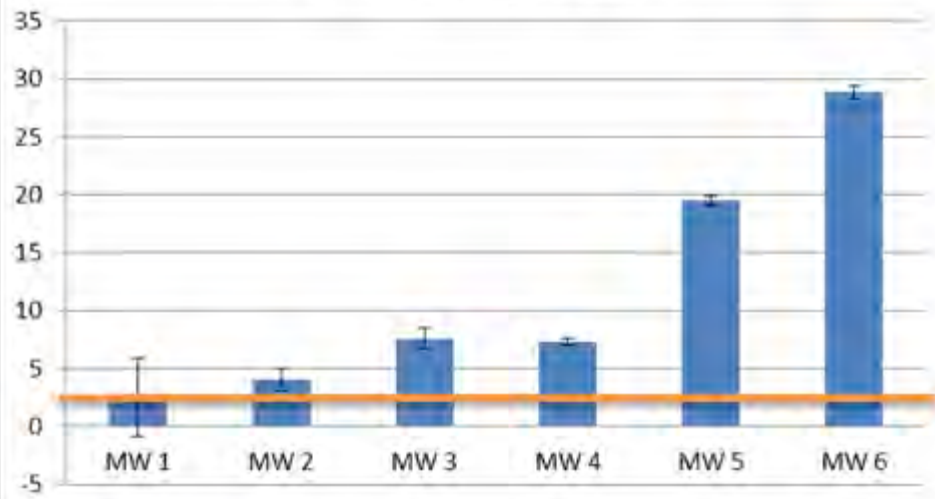
Monitor Well  $\delta^{15}\text{N}$ , 0/00

MW - 1, MW - 5

MW - 2, MW - 4, MW - 6

MW - 3

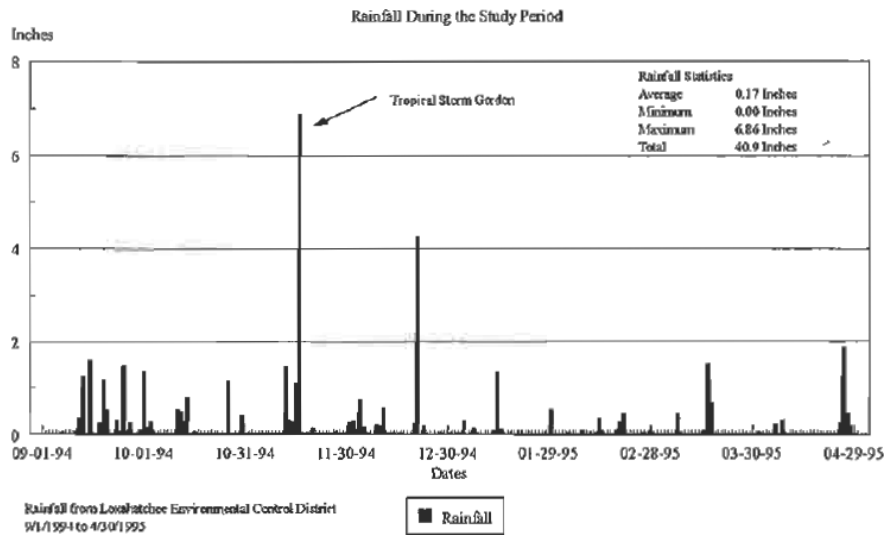
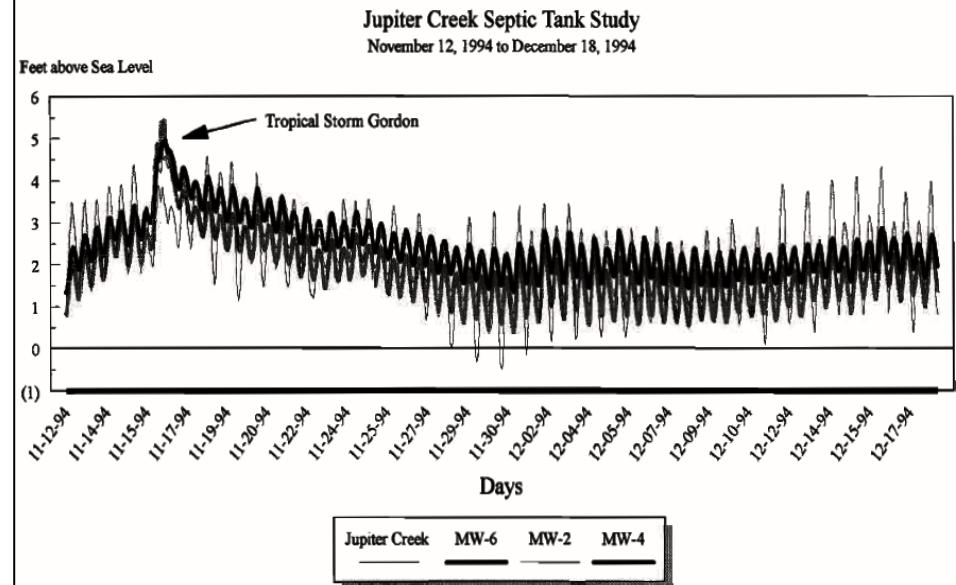
# Tidal Groundwater Flow

- Strong tidal influence on groundwater flow and direction
- Rain during wet season caused groundwater level to rise
  - Eskuchen residence septic tank in violation of 2 foot vadose rule

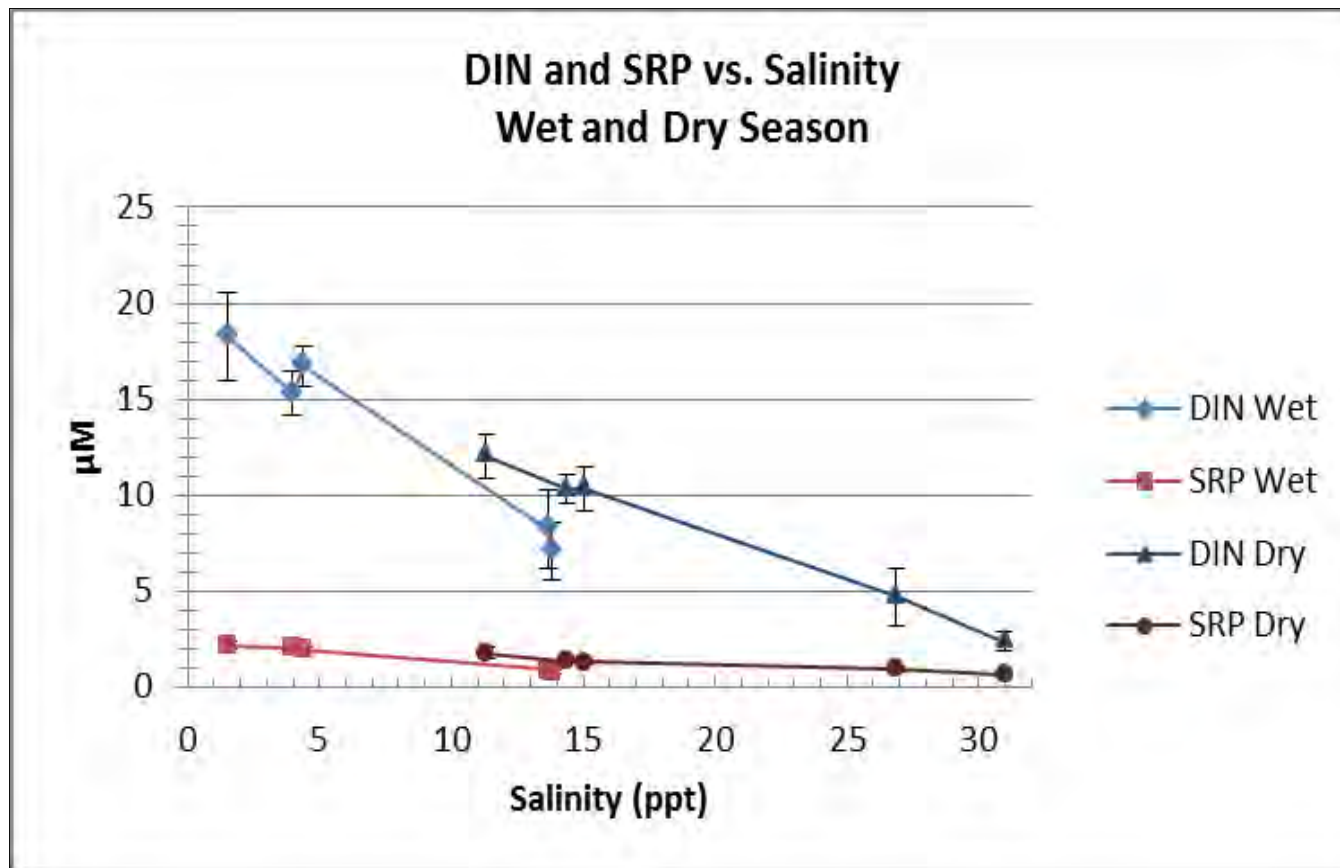
# Groundwater Nutrient Transport

- Groundwater flow 0.66 – 6.16 ft/day
  - All flow towards Jupiter Creek
- Sediments facilitated water movement and nutrient transport

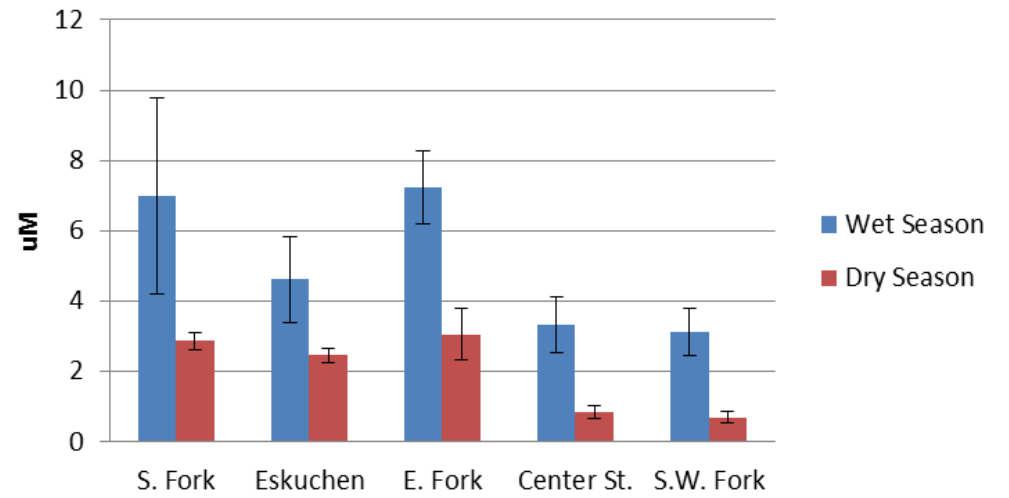
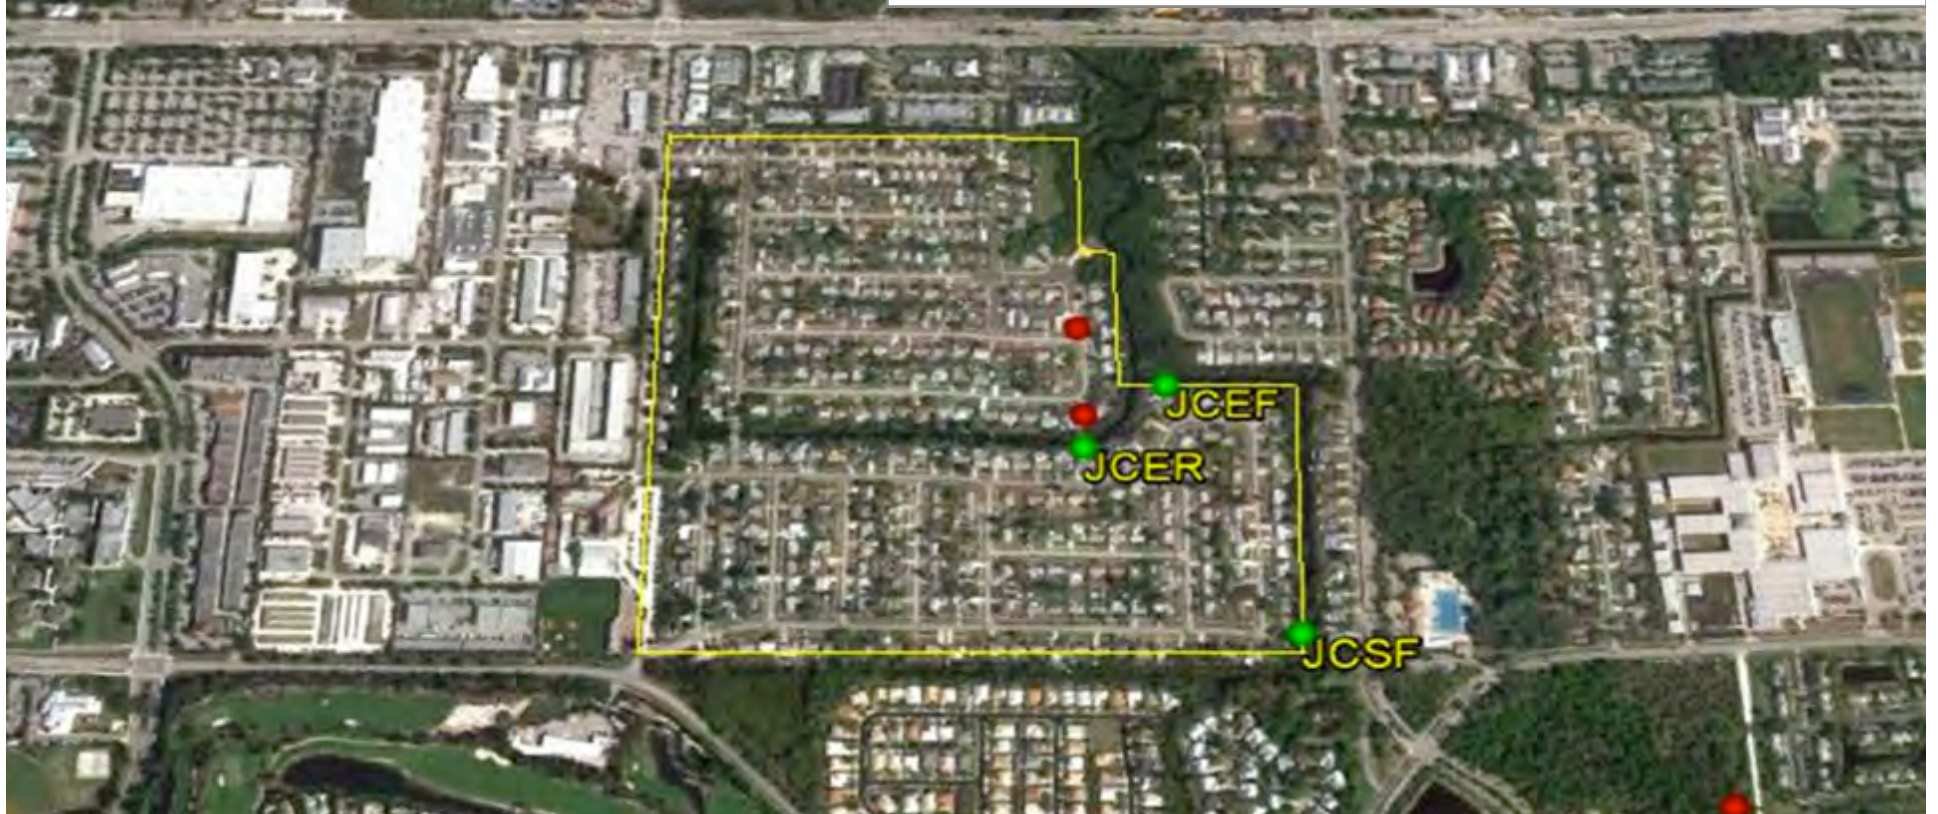
Jupiter Creek Nitrate/Nitrite (uM) Levels:  
Wet vs Dry Season

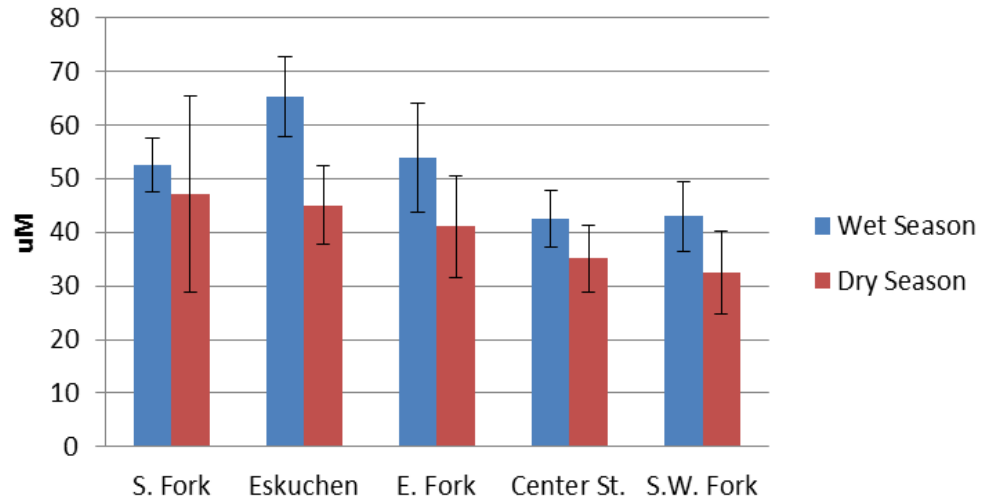
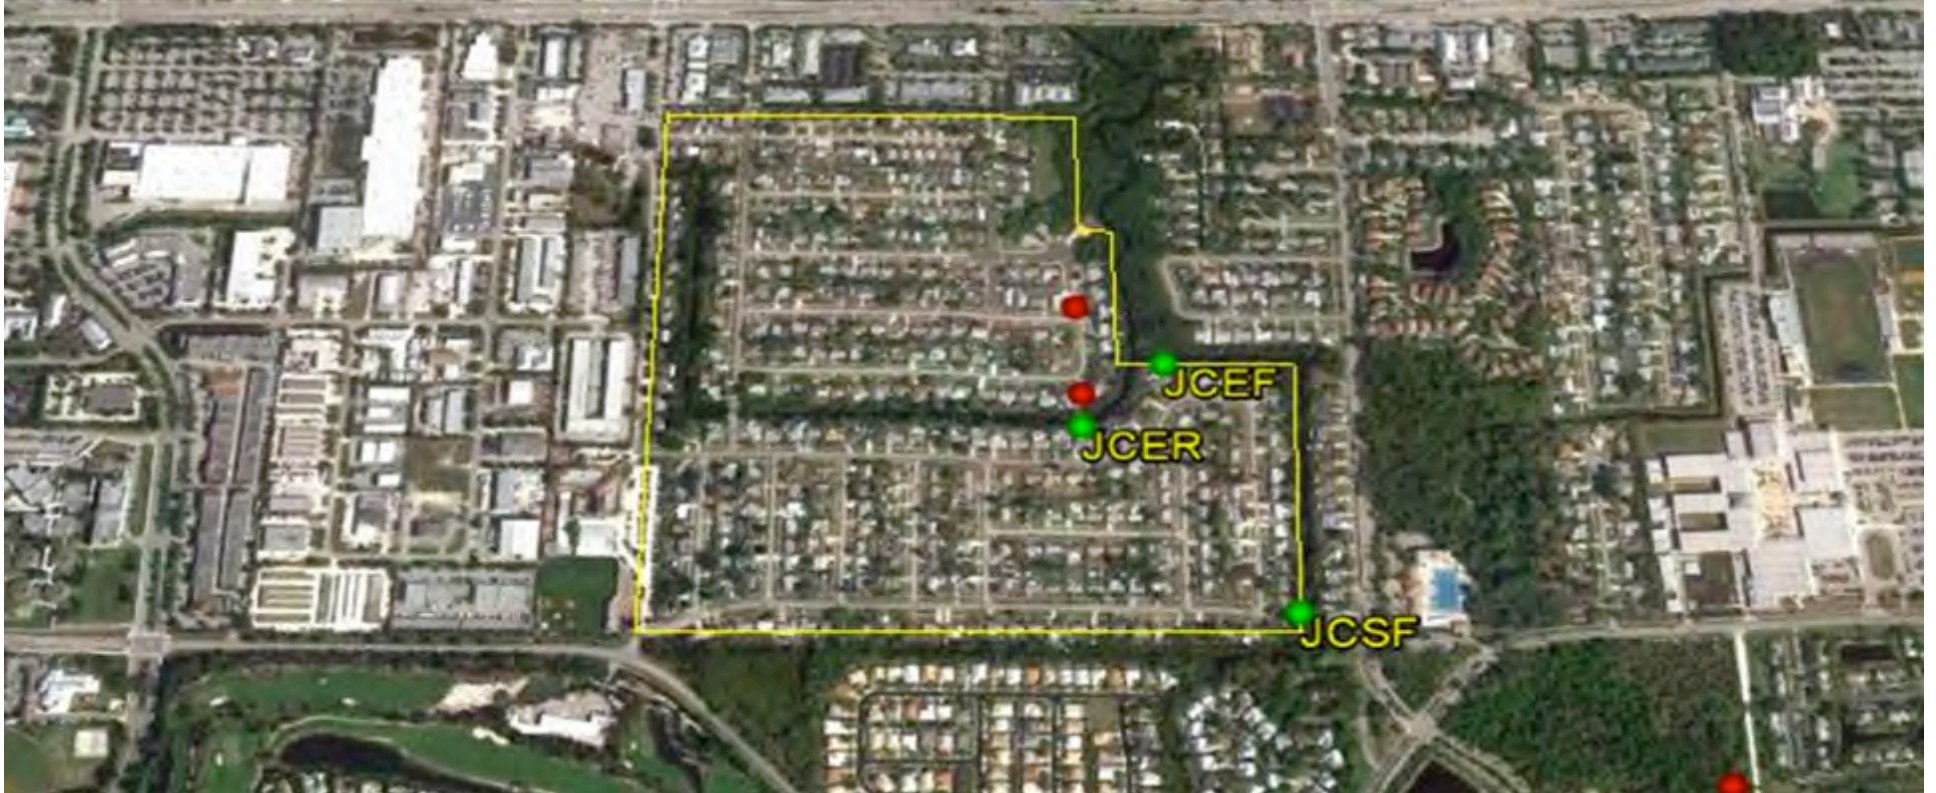
Jupiter Creek Total N (uM) Levels:  
Wet vs Dry Season

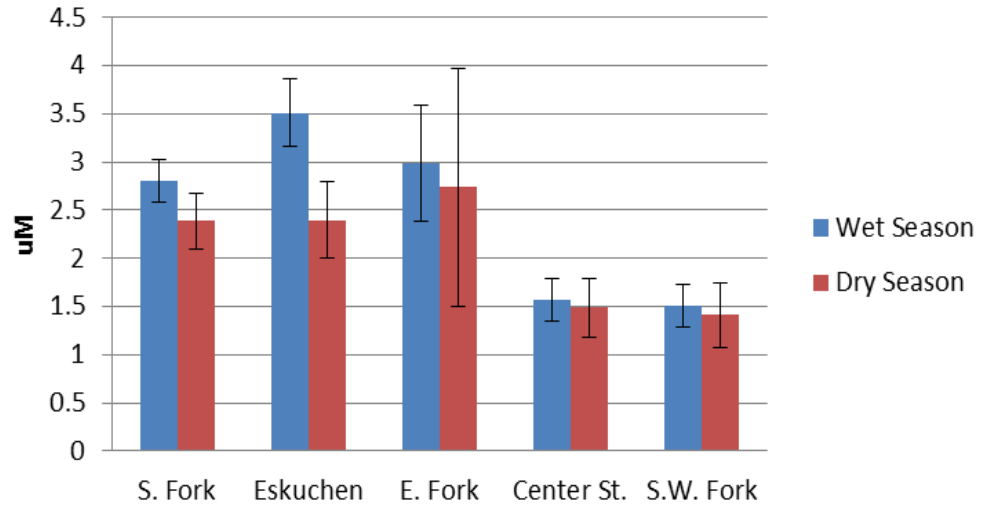
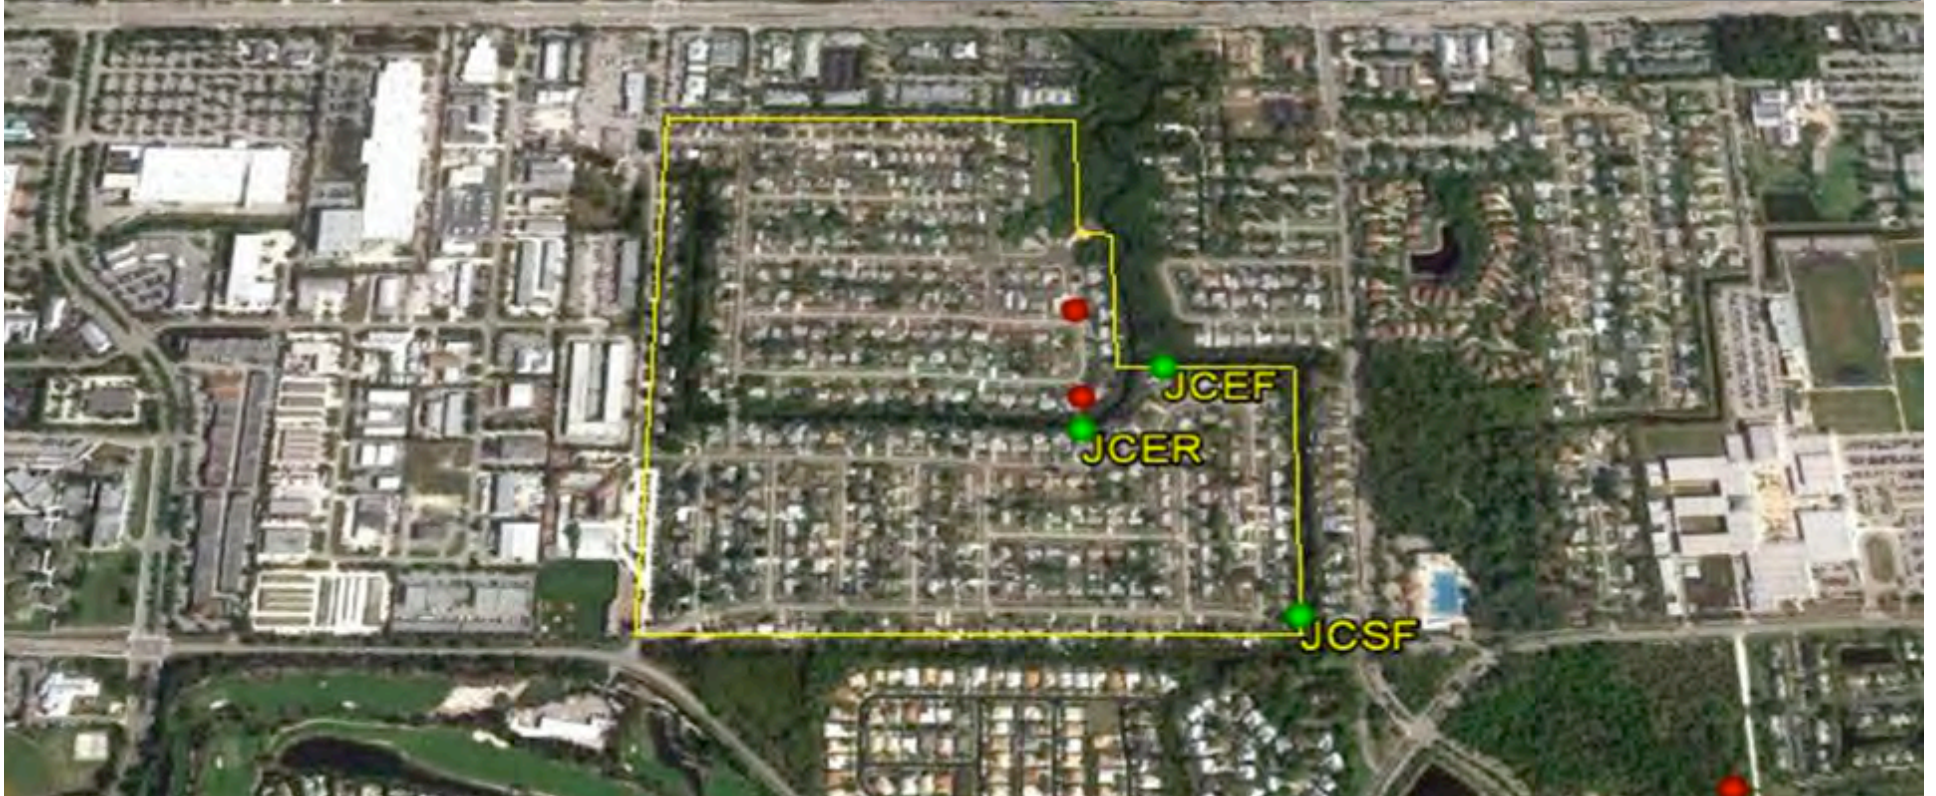
Jupiter Creek Total P (uM) Levels:  
Wet vs Dry Season

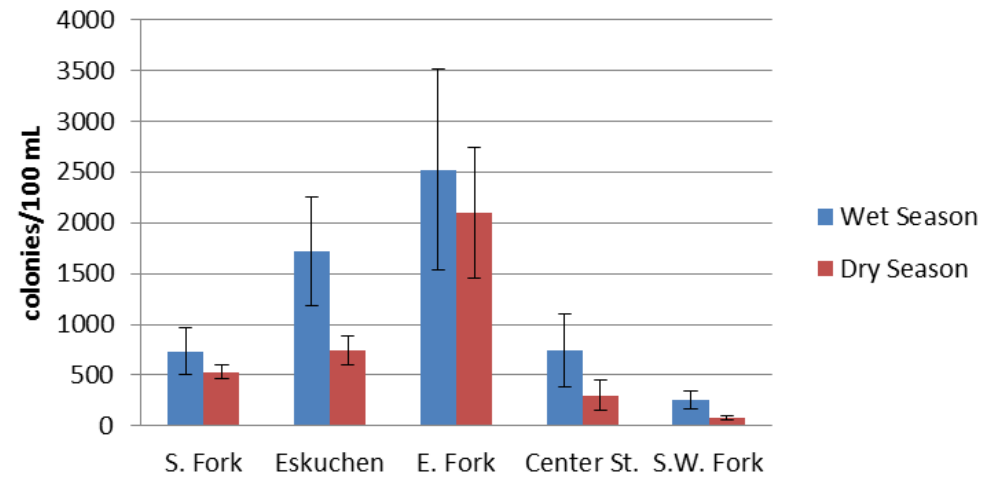
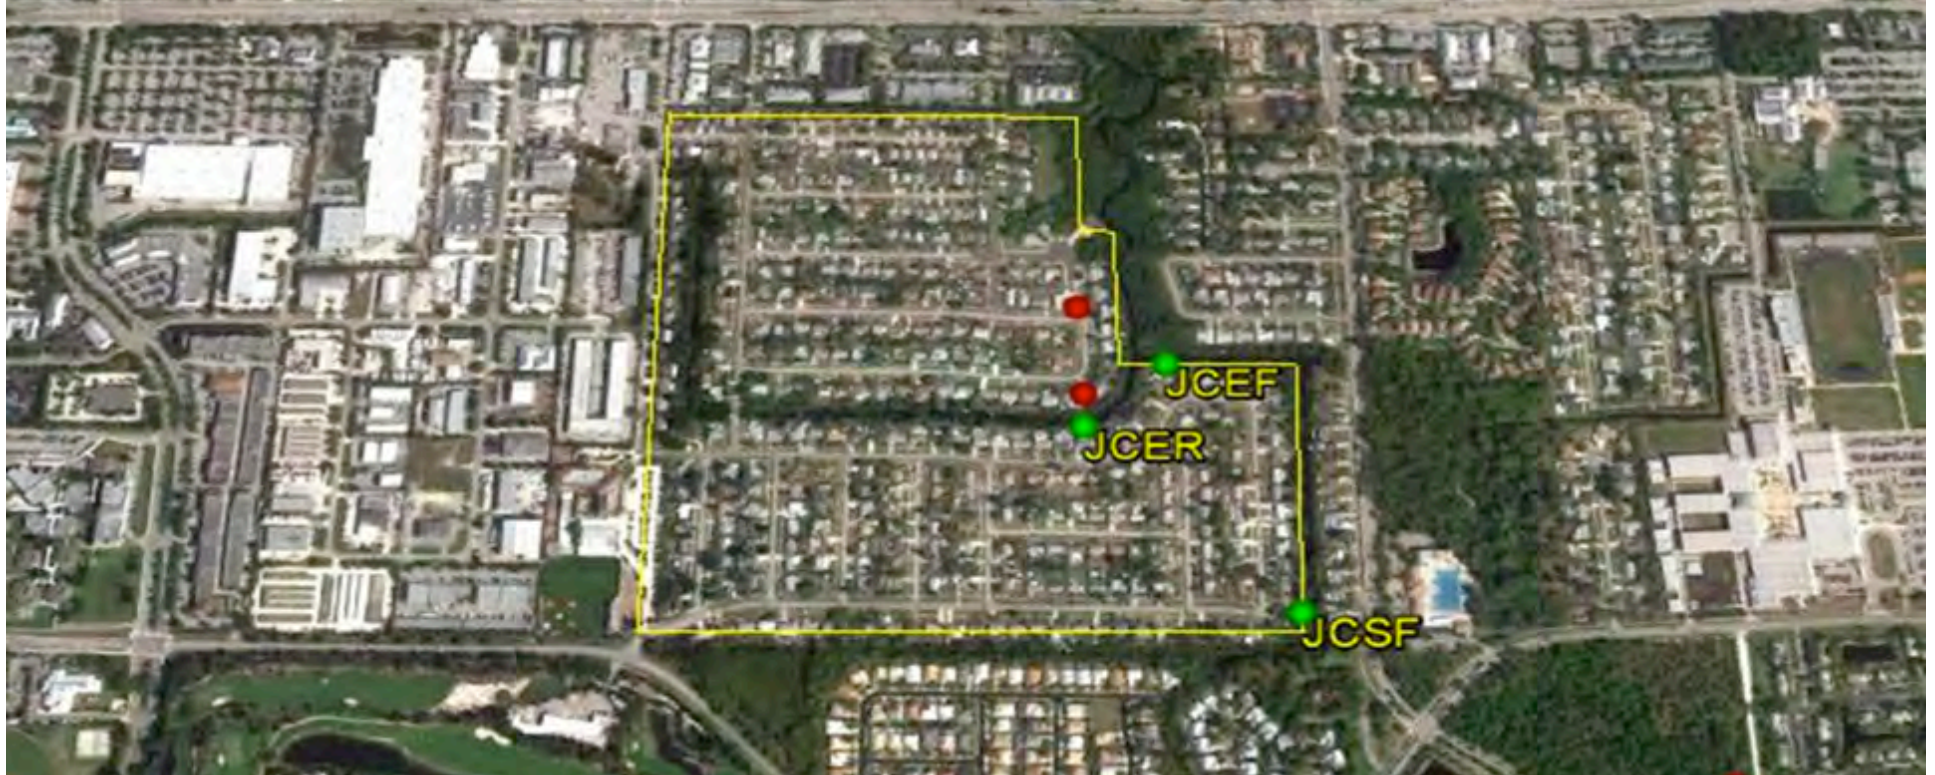
**Jupiter Creek Fecal Coliform (colonies/100 mL) Levels:  
Wet vs Dry Season**

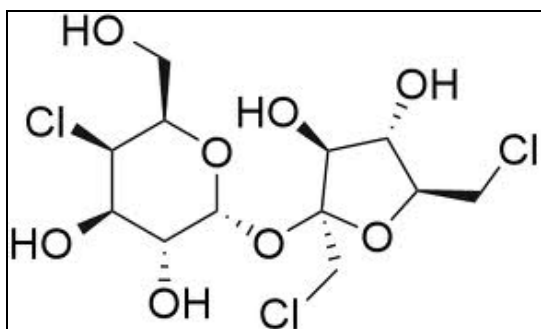
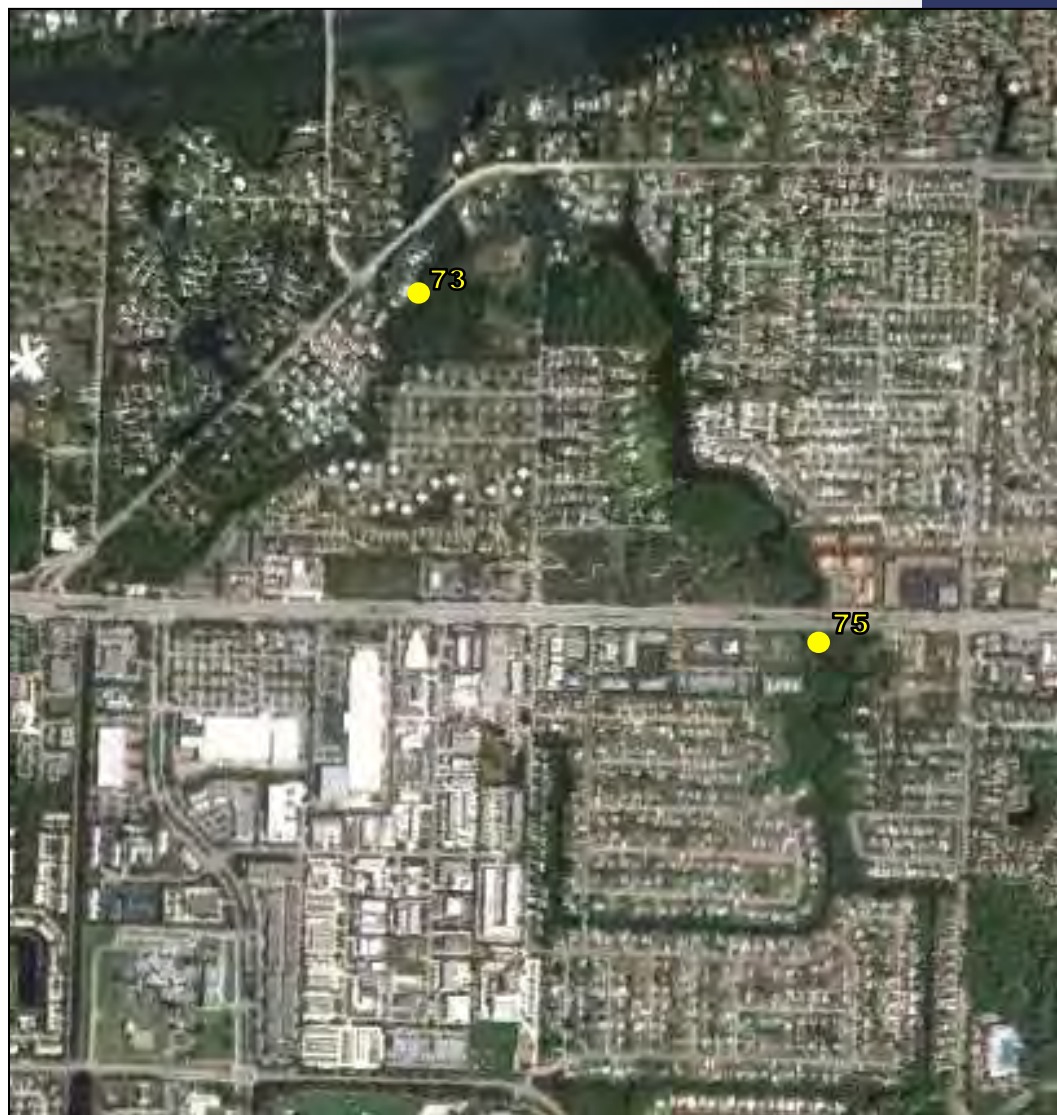
- Sucralose
- Compare 2 adjacent tidal creeks

Site	Falling Tide	Rising Tide
73	5900 ng/L	340 ng/L
75	370 ng/L	400 ng/L
