FINAL STREAM RESTORATION ASSESSMENT REPORT – 2009

**NC State University
January 2010**

For
NC Clean Water Management Trust Fund

Introduction: In 2006, NC State University was awarded a monitoring contract with the Clean Water Management Trust Fund (CWMTF) (2005A-900). The purpose of the contract was to establish an evaluation protocol for assessing a subset of the CWMTF's stream restoration, stormwater and agricultural best management practices (BMP) projects. The project includes a field evaluation of forty two existing stream restoration, stormwater and agricultural projects, to provide a snapshot of project effectiveness and water quality benefits. NC State University was asked to prepare a rapid, yet effective evaluation of these projects. These evaluations were planned for a single project visit and used to assess whether the project were likely to meet their proposed goals. Eighteen stream sites were selected by review of CWMTF files and discussions with project managers for the initial assessment work that was conducted during the summer of 2006. In addition, in 2008 and 2009 eleven additional sites were evaluated and five sites from the 2006 surveys were revisited and re

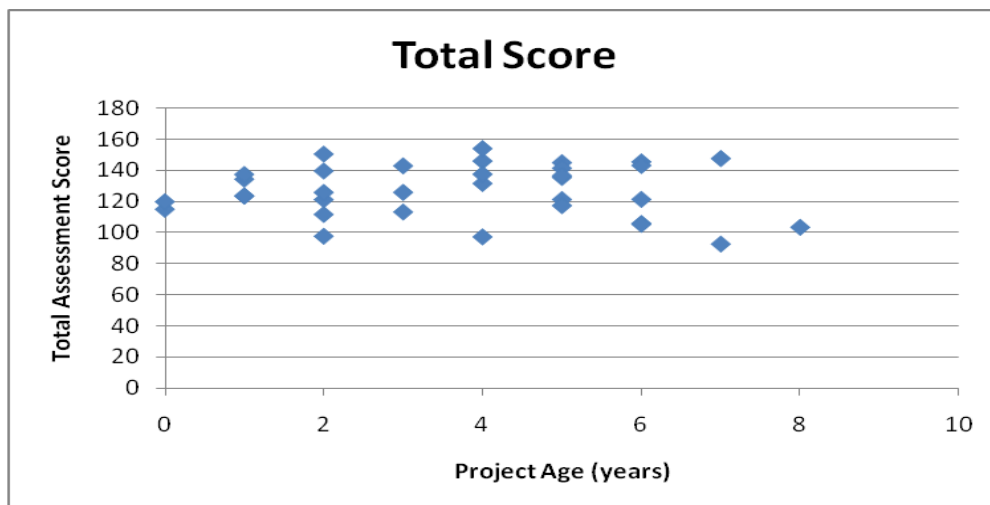
Figure 5. Comparison of restoration effectiveness (i.e. total index score) to project age.

- Project Age.* Projects ranged in age from 0 to 8 years since implementation. The age of the project affects the degree to which the ecosystem has recovered from degradation and disturbance. Age influences the growth of vegetation, establishment of microhabitats, and physical sorting of sediments following variable hydrologic events. Unlike traditional engineering projects, stream restorations are expected to improve over time as vegetation develops and bedform diversity develops naturally. Three factors confound this expected trend in this study. The first is the variability between sites, the second is that different types of projects are selected as CWMTF and grantees become more sophisticated regarding suitable projects, and the third is improvement in restoration practices. Figure 5 shows the comparison of effectiveness ratings for all projects in

relation to project age. The results are not statistically significant and there is no visual trend indicating a causal relationship. Figure 6 illustrates the separate components of the evaluation (instream structures, vegetation, invertebrate community composition and habitat, and channel condition) as they vary with project age. In 2006, no trends were identified. However, with the 11 new sites and five revisits added to the data set there is a statistically significant trend indicating an improvement in structure function and condition with newer projects, likely due to an improvement in design and installation of structures that has resulted from training, education and more experience.

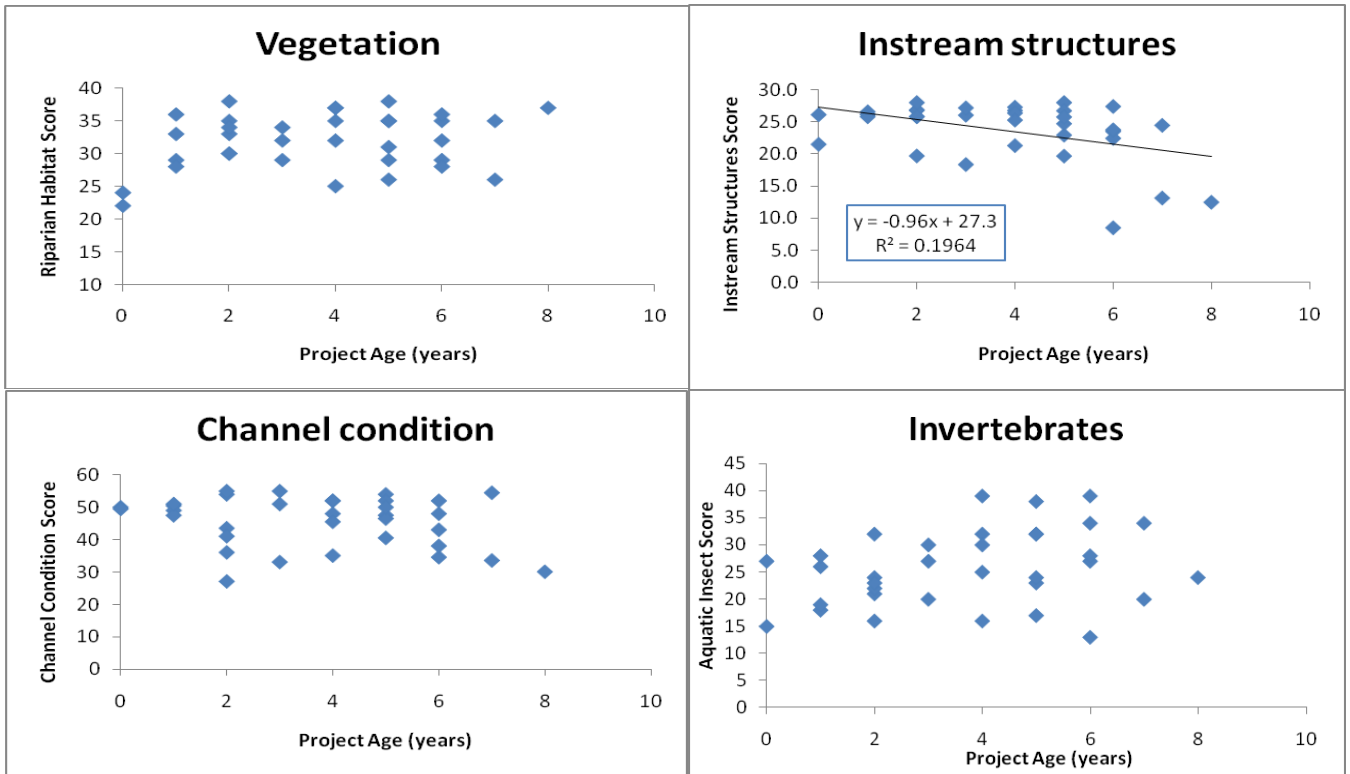
Figure 6. Comparison of separate aspects of restoration effectiveness (as measured by index scores) with age. Project ages ranged from zero to eight years.

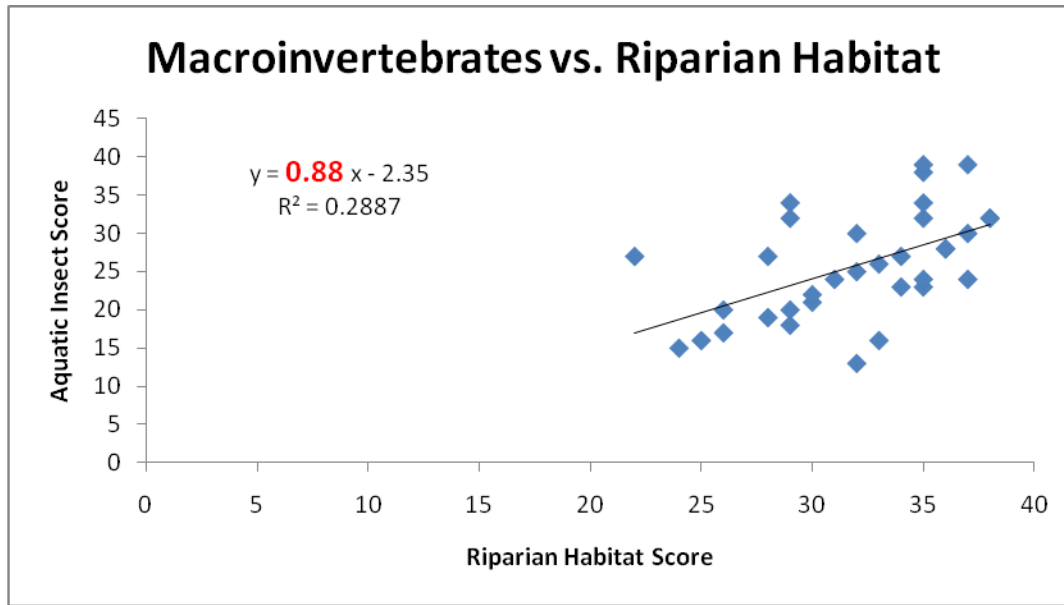
Figure 9: Regression comparison of aquatic insect score to riparian habitat score.

In addition, we hypothesized that of the four components assessed the macroinvertebrate communities are the one factor that is most likely dependent on the other elements assessed, including riparian habitat, instream structures and channel condition. Therefore, we compared the aquatic community scores to these other assessment variables to determine if a relationship exists. Of the three comparisons, it was determined that the aquatic insect score only had a statistically significant relationship with the riparian habitat score (see Figure 9). The positive slope of the trend (0.88) indicates that the observed quality of macroinvertebrates was directly correlated with the quality of riparian habitat.

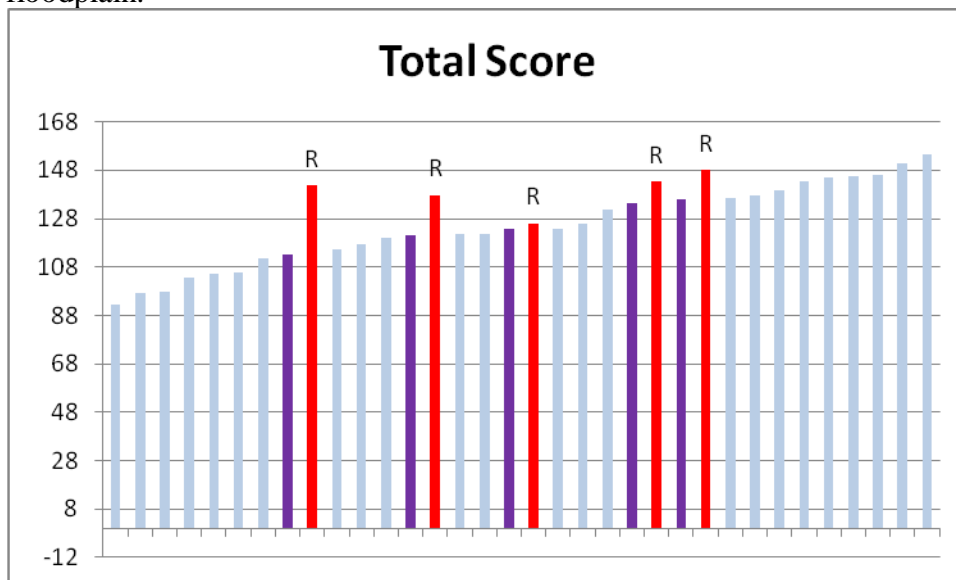
Figure 10: Comparison of restoration effectiveness for five project revisits. Projects are arrayed from lowest to highest index score. Revisited sites are indicated in purple for their initial assessment in 2006 and in red for their revisit score in 2008.

In addition, we evaluated the results of the five site revisits. The five sites, including Ambrose, Harris/Howard, Raccoon, Sharp and Upper Laurel, were originally scored in 2006 and revisited and rescored in 2008. These five sites were selected because they were all fairly recently constructed and showed a great potential to mature and improve in quality over time. Figure 10 indicates that all five revisit sites exhibited an improvement in restoration performance. The range of improvement was 1.9 to 24 percent with a mean improvement of 11.2%. The least improvement occurred at Ambrose Creek as a result of recent mowing of the entire creek and floodplain.

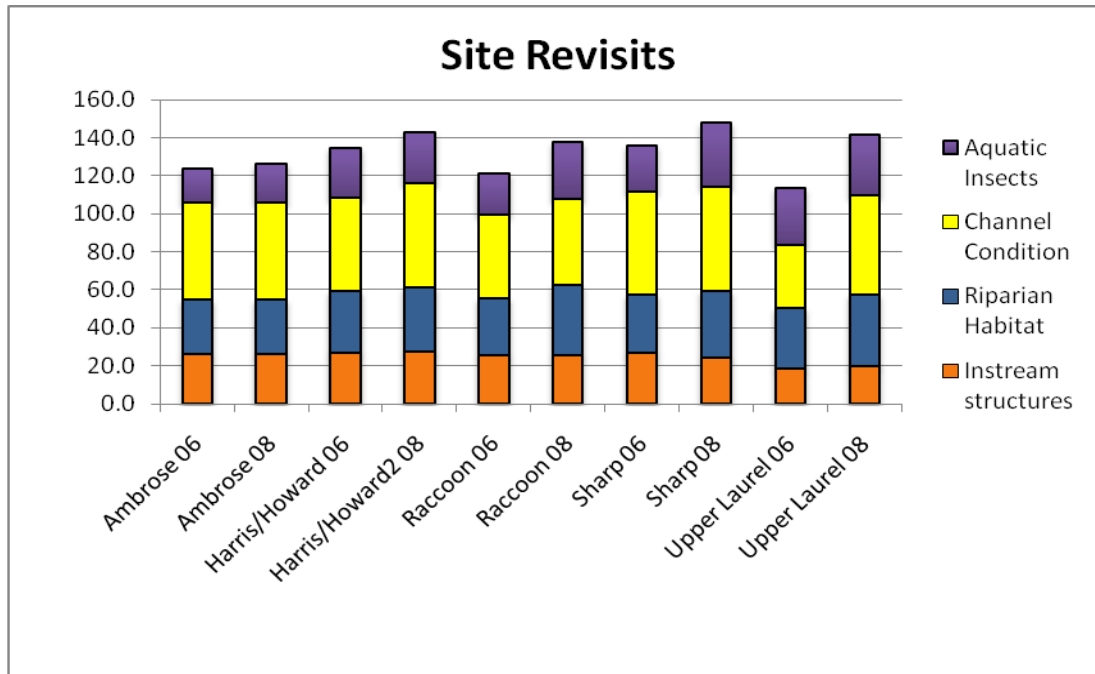
Figure 11: Comparison of restoration effectiveness for five project revisits.

Figure 11 indicates the relative area of score for the four components assessed, including instream structures, channel condition, riparian habitat and aquatic insects. The graph indicates that very little if any change occurred in instream structures as could be expected. Rather improvements were realized in channel condition, riparian habitat and aquatic insects.
