**ROCKY BRANCH - PHASE 1 STREAM RESTORATION
2007 FINAL MONITORING REPORT**

**FOR NORTH CAROLINA
DEPARTMENT OF TRANSPORTATION**

Prepared by NC Sea Grant
Box 8605, NC State University
Raleigh, NC 27695
UNC-SG-10-12

Project Designed by: AECOM (formerly EarthTech)

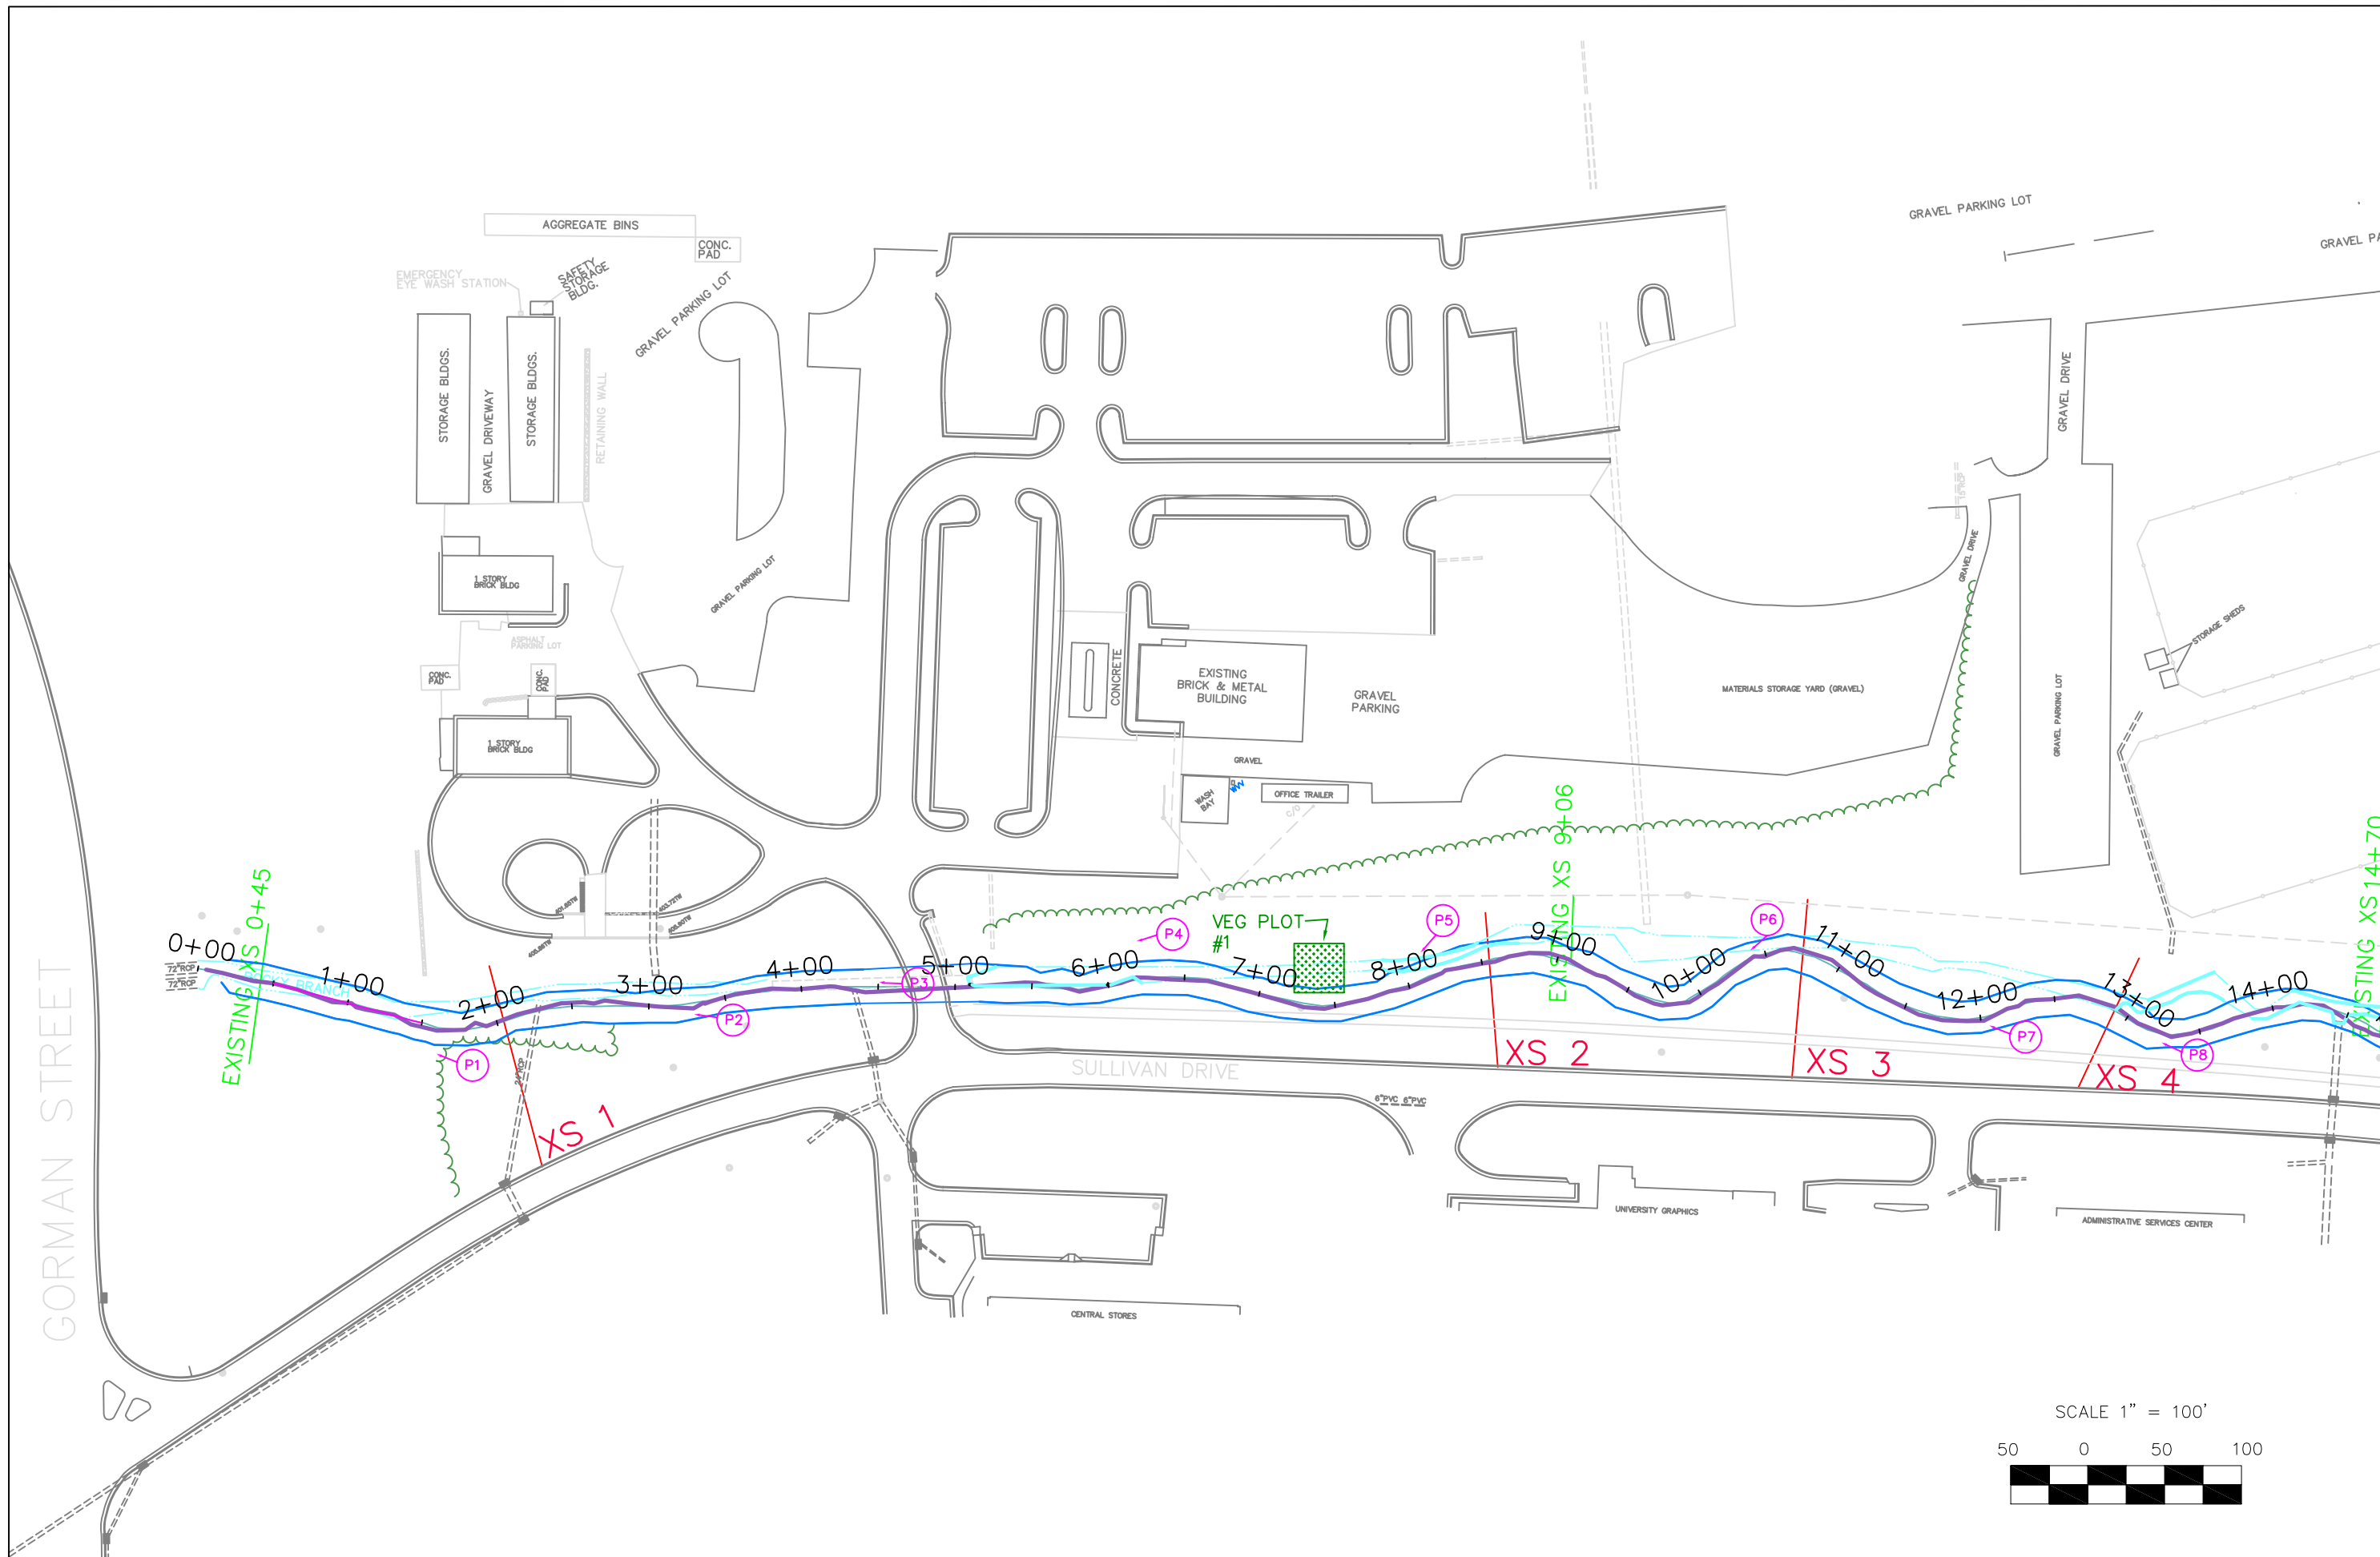
ROCKY BRANCH PHASE I NC STATE UNIVERSITY WAKE COUNTY, NC				BIOLOGICAL & AGRICULTURAL ENGINEERING Weaver Lab Campus Box 7625 North Carolina State University Raleigh, NC 27695	
MONITORING PLAN SHEET FIGURE 2a		1		NO	
DATE	8/7/2008	BAD		DRN	CHK
PROJECT NO.		BAD		DRN	CHK
FILENAME	RBASBLT.DWG	BAD		DRN	CHK
SHEET NO.	Monitoring Sheet 1 of 3	BAD		DRN	CHK
DRAWING NO.		BAD		DRN	CHK
REVISIONS					
NO					
DATE		8/7/2008
